CONCO CASE STUDY

GLOBAL TIRE MANUFACTURER MANAGED RELIABILITY PROGRAM

OIL ANALYSIS AND SIDE STREAM FILTRATION

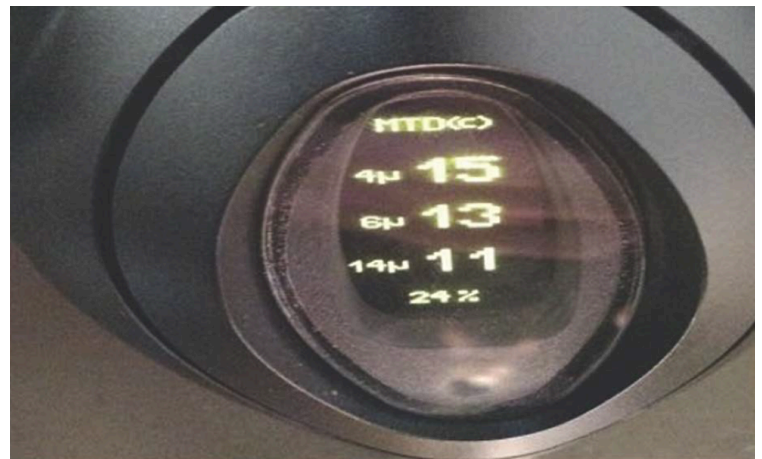
An inline laser particle counter provided real-time oil analysis

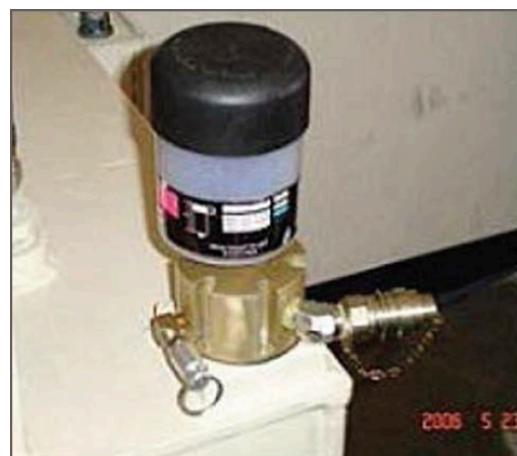
Each reservoir was outfitted with a Conco BSF (Breath/Sampler/Filler) to prevent moisture accumulation while allowing the system to breath as well as provide a consistent sample and connection point for the filter cart. The BSF kits also provided the added benefit of reducing opportunities for contamination by eliminating the need to open the reservoir for sampling or filtering.

Figure 1. BSF kit installed on a hydraulic oil reservoir

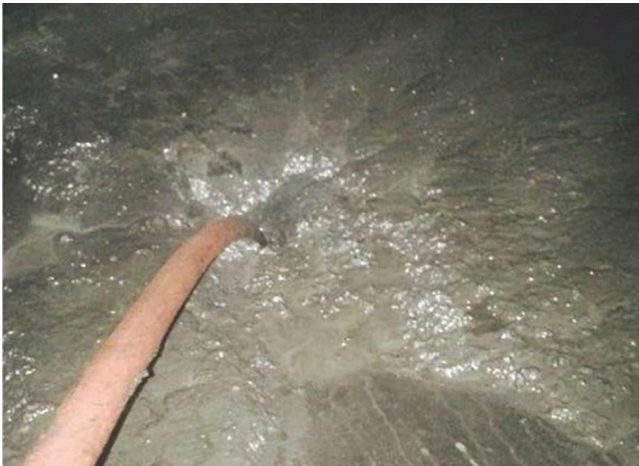
Figure 2. Oil reservoir prior to annual cleaning

The final component of the ISO cleanliness program was annual cleanings of each hydraulic reservoir. To ensure that each system was free of any dirt and debris Conco would clean each system’s reservoir every year. During a shutdown period, Conco's confined space certified personnel would drain and clean the reservoir, inspect/replace suction strainer, replace all filters, and inspect/replace reservoir access gasket. By cleaning the reservoirs every year, we were able to ensure that none of the build up on the bottom and walls of the tank were transferred into the hydraulic system.

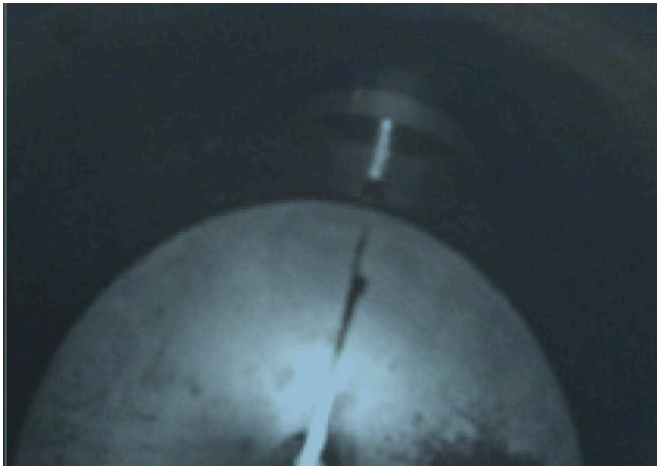
Figure 3. Clean oil reservoir after annual cleaning
