CONCO CASE STUDY

GLOBAL TIRE MANUFACTURER MANAGED RELIABILITY PROGRAM

OIL ANALYSIS AND SIDE STREAM FILTRATION

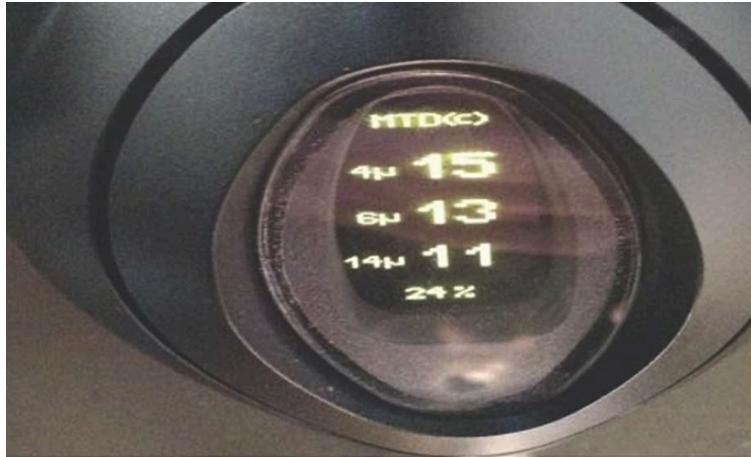
An inline laser particle counter provided real-time oil analysis

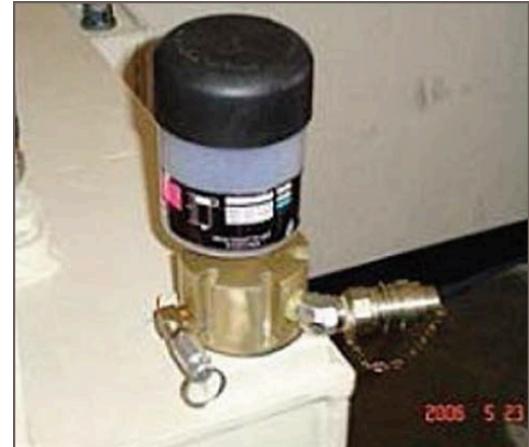
Figure 1. BSF kit installed on a hydraulic oil reservoir

Each reservoir was outfitted with a Conco BSF (Breath/Sampler/Filler) to prevent moisture accumulation while allowing the system to breath as well as provide a consistent sample and connection point for the filter cart. The BSF kits also provided the added benefit of reducing opportunities for contamination by eliminating the need to open the reservoir for sampling or filtering.

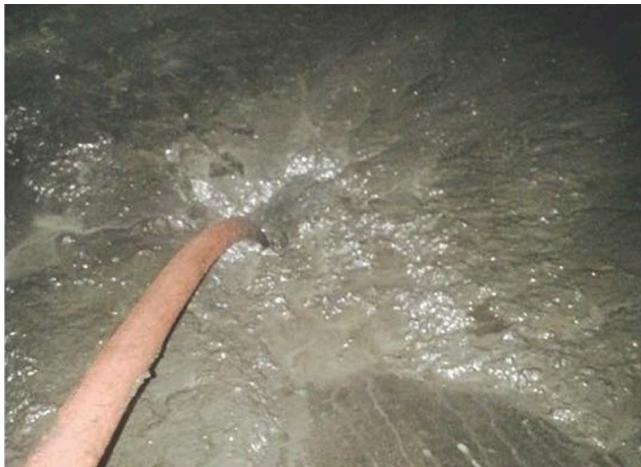
Figure 2. Oil reservoir prior to annual cleaning

The final component of the ISO cleanliness program was annual cleanings of each hydraulic reservoir. To ensure that each system was free of any dirt and debris Conco would clean each system's reservoir every year. During a shutdown period, Conco's confined space certified personnel would drain and clean the reservoir, inspect/replace suction strainer, replace all filters, and inspect/replace reservoir access gasket. By cleaning the reservoirs every year, we were able to ensure that none of the build up on the bottom and walls of the tank were transferred into the hydraulic system.

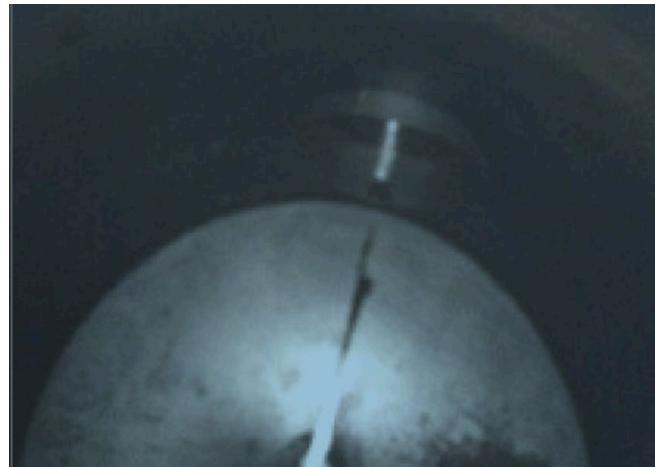
Figure 3. Clean oil reservoir after annual cleaning
